4-FACE FUEL INSPECTION

FOUR SIDED FUEL INSPECTION

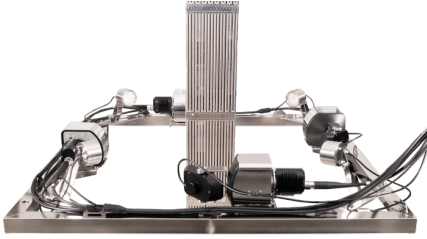
The 4-FACE Fuel Inspection is performed during regular offload in a PWR to find failed fuel. A system of four HD cameras mounted on a frame is placed above the upender to record a video of all four sides and the bottom nozzle of each fuel assembly passing by. This gives an immediate verification of fuel assembly integrity, without affecting the critical path.
